AVIATION INVESTIGATION REPORT
A05P0103

TAIL-ROTOR STRIKE (EXTERNAL LOAD) – LOSS OF CONTROL

TRANSPORT CANADA
MBB BO 105 HELICOPTER C-GCHX
BELLA BELLA, BRITISH COLUMBIA
07 MAY 2005

Report Number A05P0103

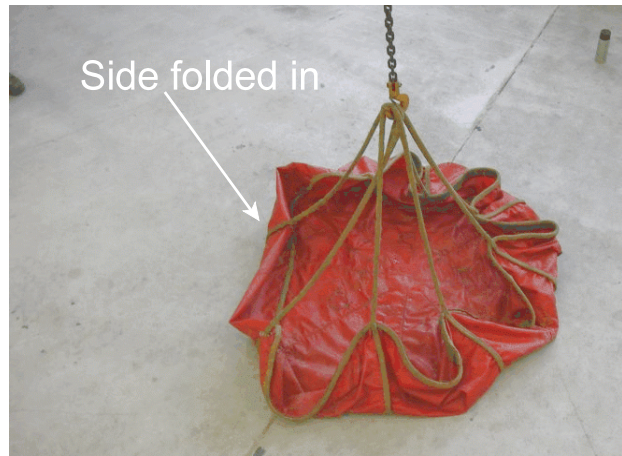
Figure 1. Bonnet

The helicopter was moving at about 60 knots when the pilot felt and noticed the bonnet open. The sling gear was still in it, but the bonnet was folded in (see Figure 1) between the one o'clock and the two o'clock position. About two seconds later, the bonnet and longline travelled to the port side of the helicopter, appearing at the pilot's ten o'clock position, slightly above eye level. It moved backwards and out of sight, then there was a bang followed by some thrashing noises, and the helicopter began to turn right. The pilot could see the line hanging from high on the tail, trailing down, back and out at about the four o'clock position. The bonnet was not evident on the line. As this was happening, the pilot slowed the helicopter and reduced power by lowering the collective and bringing the throttles to the engine idle position. Just before impact, the pilot increased the throttles to full and raised the collective a small amount. The helicopter hit the water sooner than expected, and the pilot had not activated the emergency floatation system.

It is most likely that the polypropylene rope, used to snug the top of the bonnet, slid up the beackets and the bonnet opened in flight. The pilot described seeing the starboard front area of the bonnet folded in, likely because the separated beacket allowed the formation of an asymmetric shape. The resulting shape and the bonnet's light weight and high drag allowed the bonnet to fly up and into the flight path of the helicopter, carrying the longline with it. The longline subsequently came into contact with the tail rotor and disabled it, rendering the helicopter uncontrollable.

On 09 May 2005, Transport Canada Aircraft Services Directorate issued a safety notice, restricting operations with empty or light external sling loads.

On 25 May 2005, Transport Canada Aircraft Services Directorate produced draft Standard Operating Procedures (SOPs) for helicopter external load operations. These SOPs restrict the use of bonnets and caution pilots about light and unstable loads.
